# Ohio DOT SR 2 Embankment Repair

## Construction - Case Study

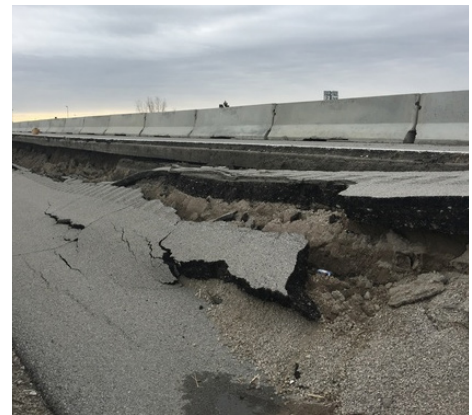
### BEFORE

In November 2017, ODOT crews noticed a crack in the pavement on the Ohio Westbound State Route (SR) 2 Ramp at SR 269 located in Northern Ohio near Sandusky. Further inspection revealed growth in the crack prompting ODOT to close the ramp's shoulder in late November. By early December, the crack expanded to a 1" difference in pavement height causing ODOT to shut down the ramp entirely. Shortly after the shutdown the pavement slid, or dropped down, leaving the ramp impassable. This caused ODOT to proactively close the right lane of Westbound SR 2. Although treating embankment failures is not new to ODOT, the Westbound SR 2 failure worsened much faster than others in the region, severely impacting the flow of traffic. ODOT targeted May 23rd for slip repair completion, in time for the Memorial Day Holiday, due to the exits importance to Lake Erie's summer tourism.

Pavement Slip  
Westbound SR 2 Ramp at SR 269 Ramp

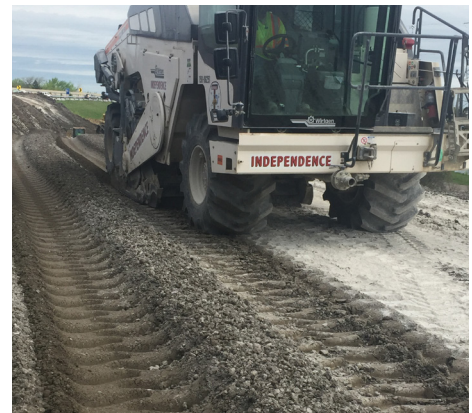
### DURING

Calciment Application  
2% - 3% Dose Rate

Repair work began early Spring 2018, a season that experienced temperatures as low as 21°F and rarely rising to 50°F, as well as above average precipitation, leaving the soil wet and unworkable. Native soils were removed, treated with Calciment and returned in 8-inch lifts. Calciment was applied at a 2% - 3% dose rate and within hours, the previously wet, unworkable soils reached optimum moisture and were ready for compaction in compliance with ODOT specification.

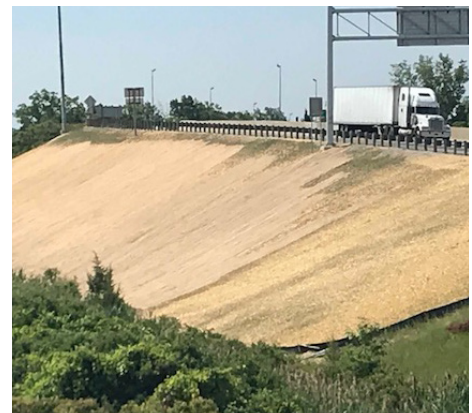
### AFTER

Final Repair  
June 15th, 2018

One lane of the repaired state route and ramp was completed by May 23rd, ahead of the busy Memorial Day weekend. The project was substantially completed on June 15th.
