CONSTRUCTION - CASE STUDY

Ohio DOT SR 2 Embankment Repair

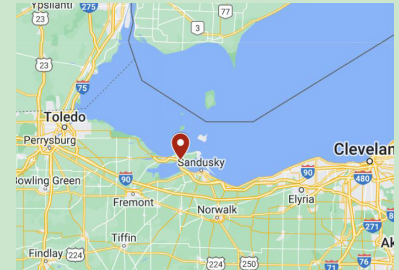
BEFORE

In November 2017, ODOT crews noticed a crack in the pavement on the Ohio Westbound State Route (SR) 2 Ramp at SR 269 located in Northern Ohio near Sandusky. Further inspection revealed growth in the crack prompting ODOT to close the ramp's shoulder in late November. By early December, the crack expanded to a 1" difference in pavement height causing ODOT to shut down the ramp entirely. Shortly after the shutdown the pavement slid, or dropped down, leaving the ramp impassable. This caused ODOT to proactively close the right lane of Westbound SR 2. Although treating embankment failures is not new to ODOT, the Westbound SR 2 failure worsened much faster than others in the region, severely impacting the flow of traffic. ODOT targeted May 23rd for slip repair completion, in time for the Memorial Day Holiday, due to the exits importance to Lake Erie's summer tourism.

When superhighways like SR 2 were originally built, embankments were typically built directly on top of the native topsoil, a method later abandoned by ODOT due to the instability of the structure. This embankment soil included moisture sensitive native soils and local granular fill that tend to move more rapidly. Excessive amounts of water penetrated the sub-base and accelerated the decomposition

Pavement Slip
Westbound SR 2 Ramp
at SR 269 Ramp

ODOT determined the best course of action was to rebuild the structure with a rock anchor at the base of the slope. The native soil was to be removed and treated with a lime-based chemical reagent to ensure optimum moisture and compaction in accordance with ODOT Specification 205 for Chemically Stabilized Embankment. Per ODOT spec, soils had to reach +/- 2% of optimum moisture and 98% compaction. Calciment® LKD, a chemical hybrid of Cement and Quicklime, was selected due to its field-proven ability to quickly dry the soil and provide the compaction required by ODOT.

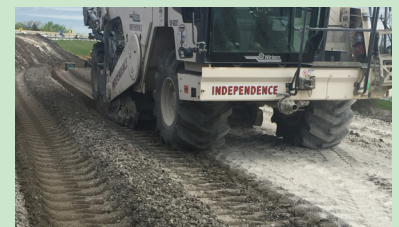
DURING

Calciment LKD Application
2% - 3% Dose Rate

Repair work began early Spring 2018, a season that experienced temperatures as low as 21°F and rarely rising to 50°F, as well as above average precipitation, leaving the soil wet and unworkable. Native soils were removed, treated with Calciment LKD and returned in 8-inch lifts. Calciment LKD was applied at a 2% - 3% dose rate and within hours, the previously wet, unworkable soils reached optimum moisture and were ready for compaction in compliance with ODOT specification.

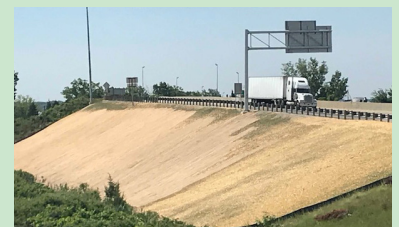
AFTER

Final Repair
June 15, 2018

One lane of the repaired state route and ramp was completed by May 23rd, ahead of the busy Memorial Day weekend. The project was substantially completed on June 15th.
