# ODOT US Route 24 Stabilization Project

## Construction - Case Study

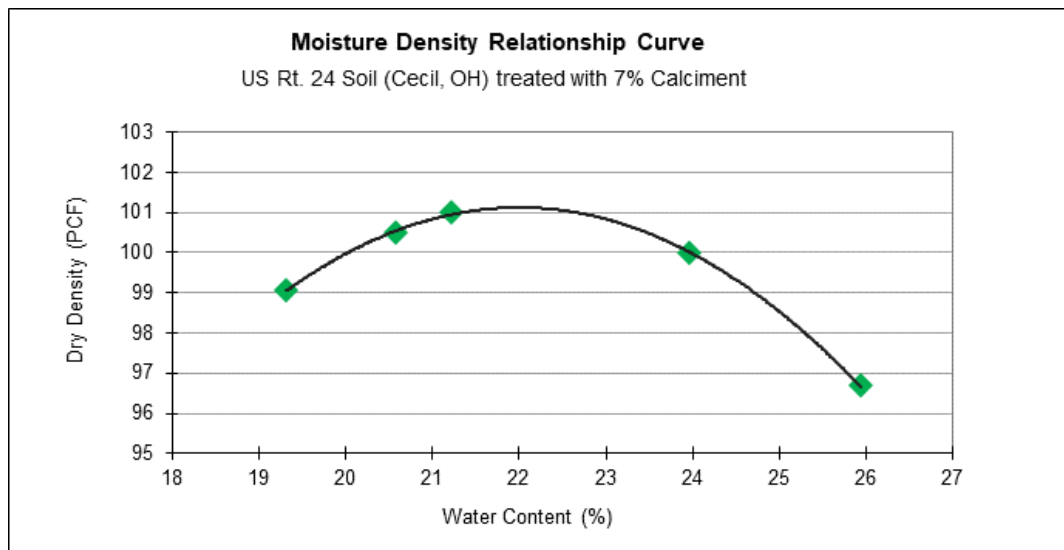
With Mintek's support, at the end of the project, ODOT and the contractor achieved their desired targets. Field recommendations were confirmed with laboratory testing, which was completed at the Carmeuse Innovation Center's soil laboratory, Mintek's parent company. A five-point moisture-density relationship curve, commonly referred to as a Proctor curve, was performed on soil samples taken from the site. After Calciment was applied, the Proctor curve showed the site conditions were in line with the ideal conditions produced in the lab. An optimum moisture content (OMC) of 22% was determined in the lab compared to the 21% OMC determined by a nuclear gauge in the field.

Per ODOT specification, the strength of soil stabilized with lime-based materials needed to be 50 psi greater than the untreated strength, with a minimum UCS of 100 psi. By treating the in-situ soil with 7% Calciment, the UCS of the soil was improved from 15 psi to 160 psi, far exceeding the strength specifications.
