#### CONSTRUCTION - CASE STUDY

## ODOT US Route 24 Stabilization Project

### EMBANKMENT REPAIR WITH CALCIMENT® LKD

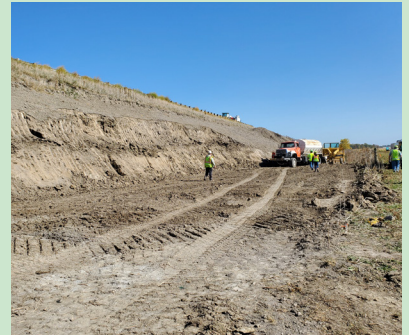
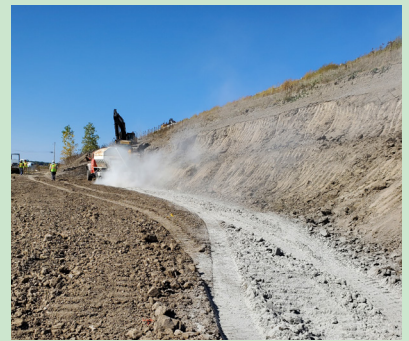
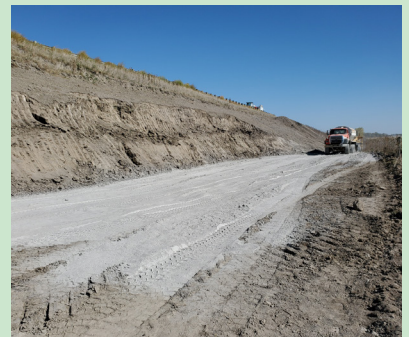
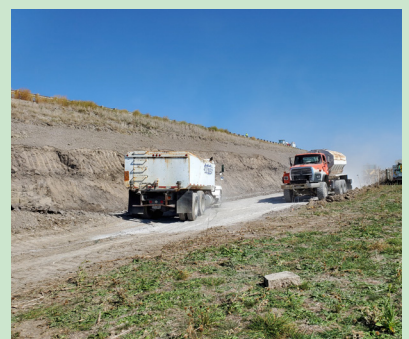
Achieving the desired moisture content and compaction targets on site proved to be difficult, so Mintek was called for support. Calciment LKD's superior drying allowed the contractor to meet project timelines by drying the saturated soil to a workable moisture content while providing the long-term strength gains needed for this project. Mintek personnel provided field support that proved to be critical as pre-project testing was not possible due to the failing condition of the embankment and the need for a quick remedy. Mintek was able to quickly assess the site conditions, evaluate the soil and provide recommendations to improve the site conditions and accelerate the project schedule. The project was completed in November of 2020.

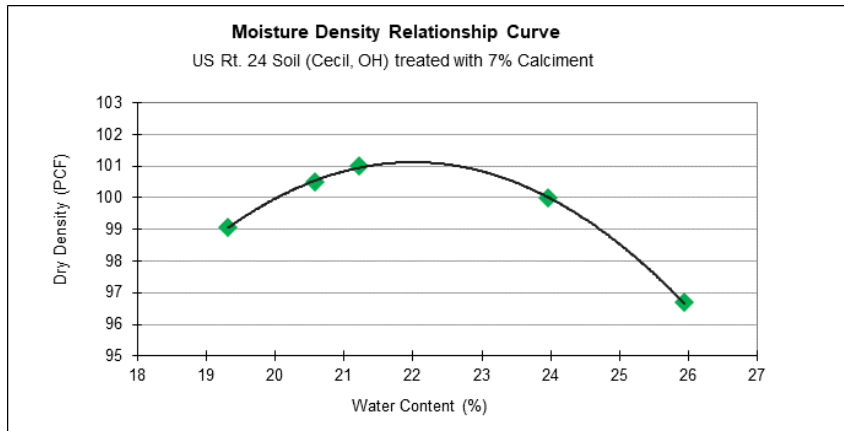
Per ODOT specification, the strength of soil stabilized with lime-based materials needed to be 50 psi greater than the untreated strength, with a minimum UCS of 100 psi. By treating the in-situ soil with 7% Calciment LKD, the UCS of the soil was improved from 15 psi to 160 psi, far exceeding the strength specifications.
