#### CASE STUDY - CONSTRUCTION

## Golf Course Cold Weather Drying Project

#### Golf Course Slip Repair

#### Construction Drying Dose Rate: 3%

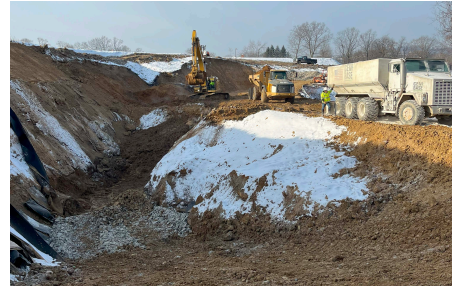
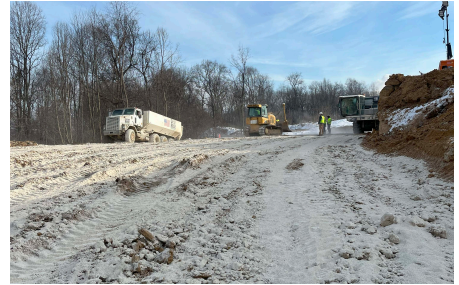
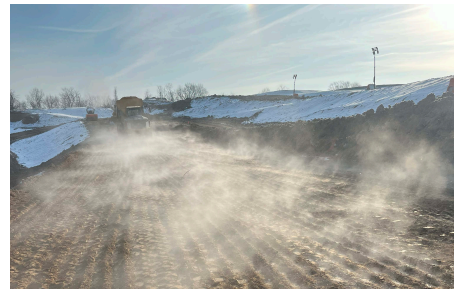
Quicklime was applied using Cem-Base's state-of-the-art Oshkosh spreader trucks with in-cab digital scales for precise application rates. Once spread, a Wirtgen tiller incorporated the material into the soil at a depth of 12 inches. The process generated significant steam, indicating the quicklime was reacting with moisture in the soil. This exothermic reaction aids in moisture evaporation. Using high-horsepower equipment ensures optimal results and effectiveness in the drying process.

Quicklime proved to be the ideal solution as it effectively dried the soil and melted the frost, allowing Cem-Base to continue placing fill. The process involved lifting the soil, insulating and sealing in the heat, and then compacting it. The heat was sealed in to maintain the drying effect. For this project, a 2% quicklime dose rate was initially used. Due to the harsh conditions, an additional 1% dose was necessary. This extra percentage helped generate more heat and allowed the steam to drive off moisture effectively.

The use of quicklime effectively dried the soil, allowing Cem-Base to stay on schedule and even get ahead despite harsh weather conditions. The ground became very firm after the final lift, indicating the effectiveness of the drying process and giving the crew the green light to move forward with confidence. This preparation ensures that the foundation is solid and stable, ready to support the upcoming construction activities. Even as temperatures dropped below zero on some days, quicklime continued to dry the soil effectively.
